DEBRIS/ICE/TPS ASSESSMENT  
AND  
PHOTOGRAPHIC ANALYSIS  
OF  
SHUTTLE MISSION STS-32R

January 9, 1990

Gregory N. Katnik  
NASA/Kennedy Space Center  
TV-MSD-22

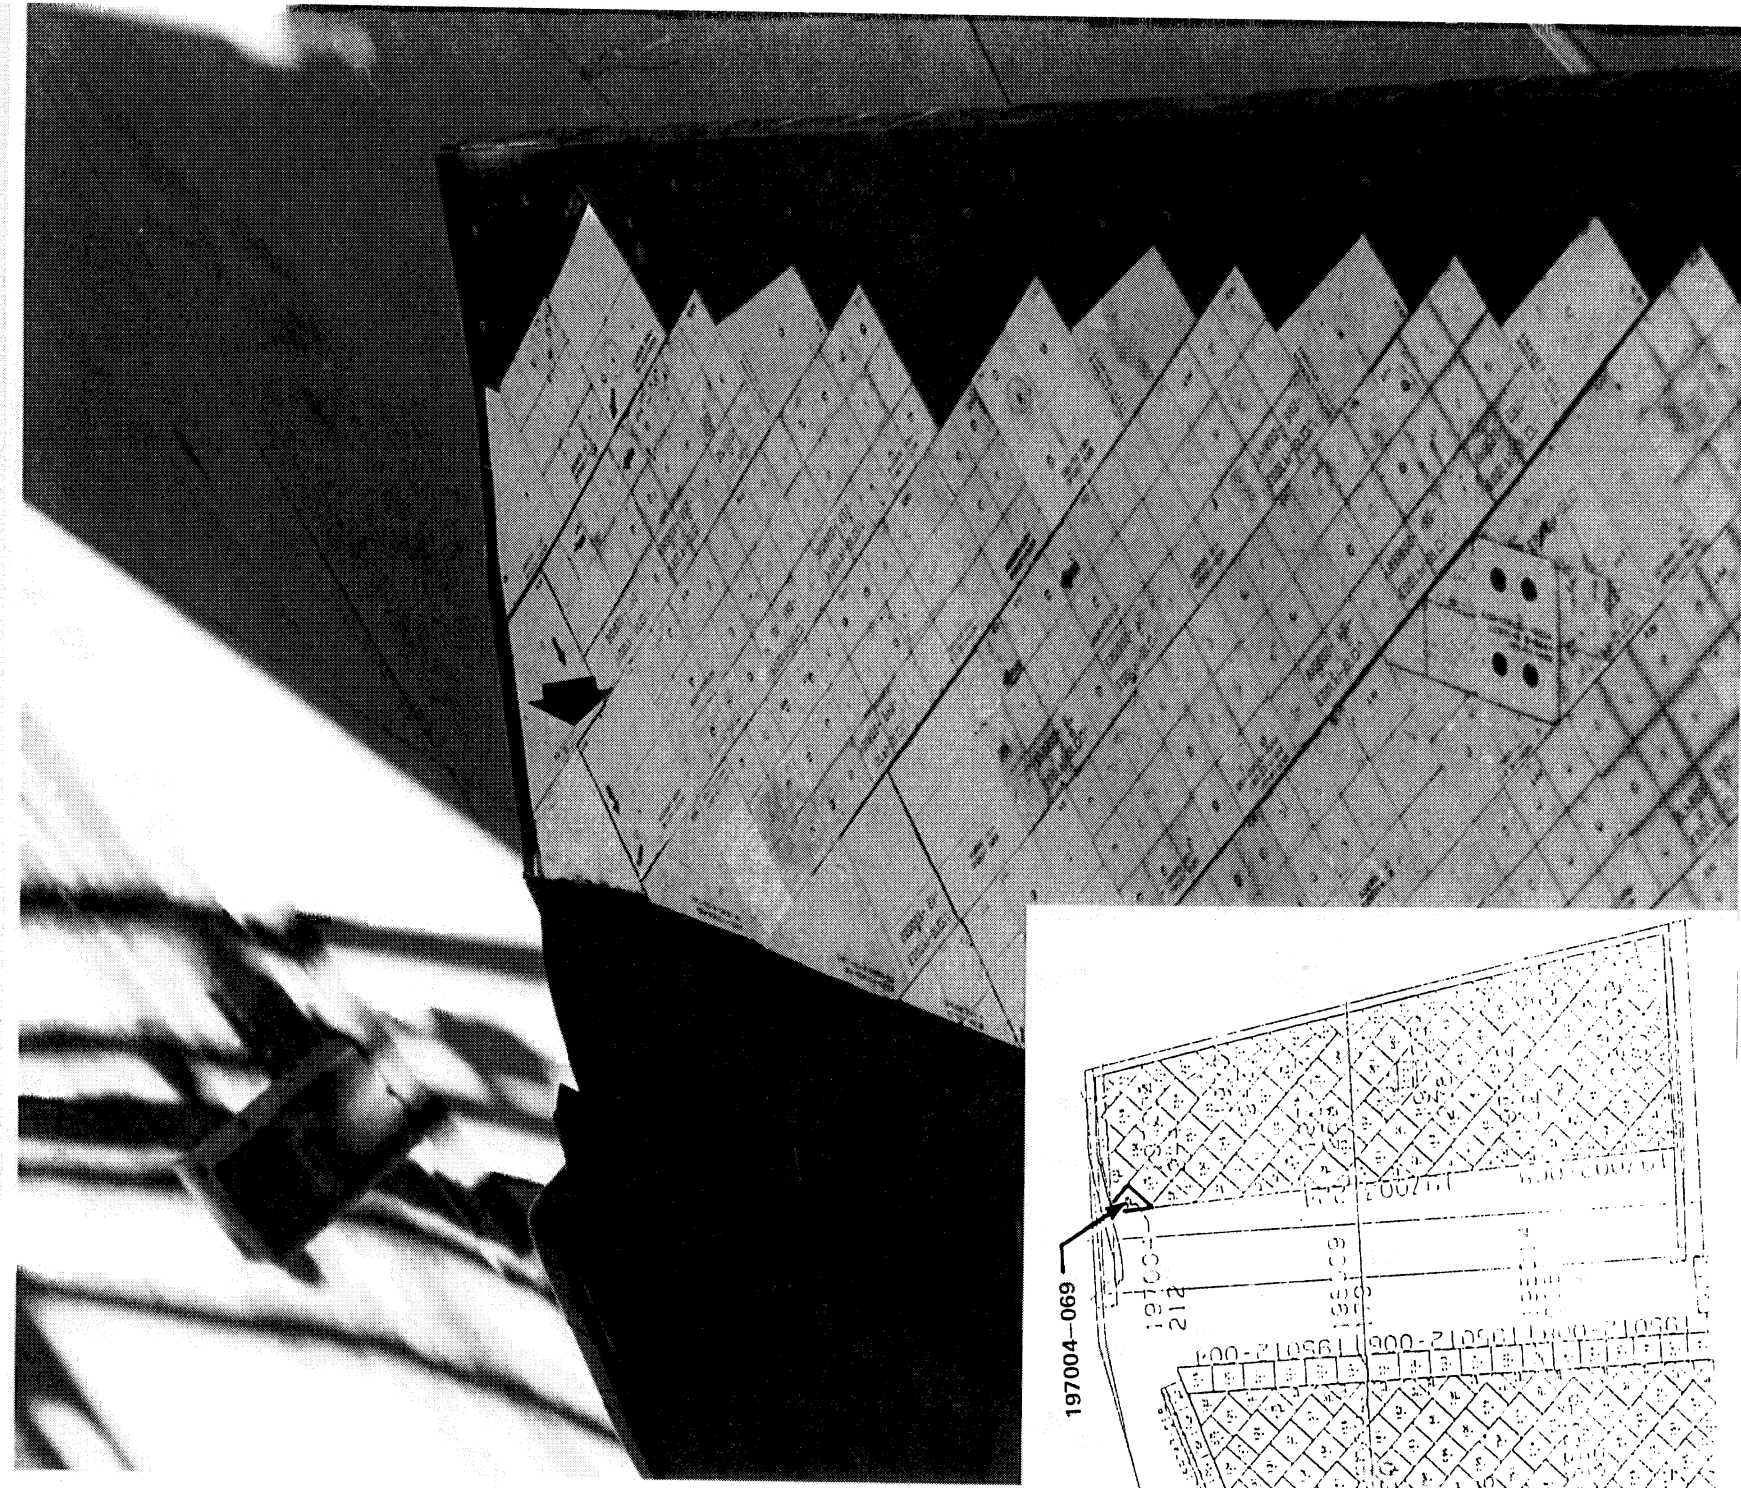
White tile screed repair missing from RH outboard elevon was visible in launch films falling from the vehicle

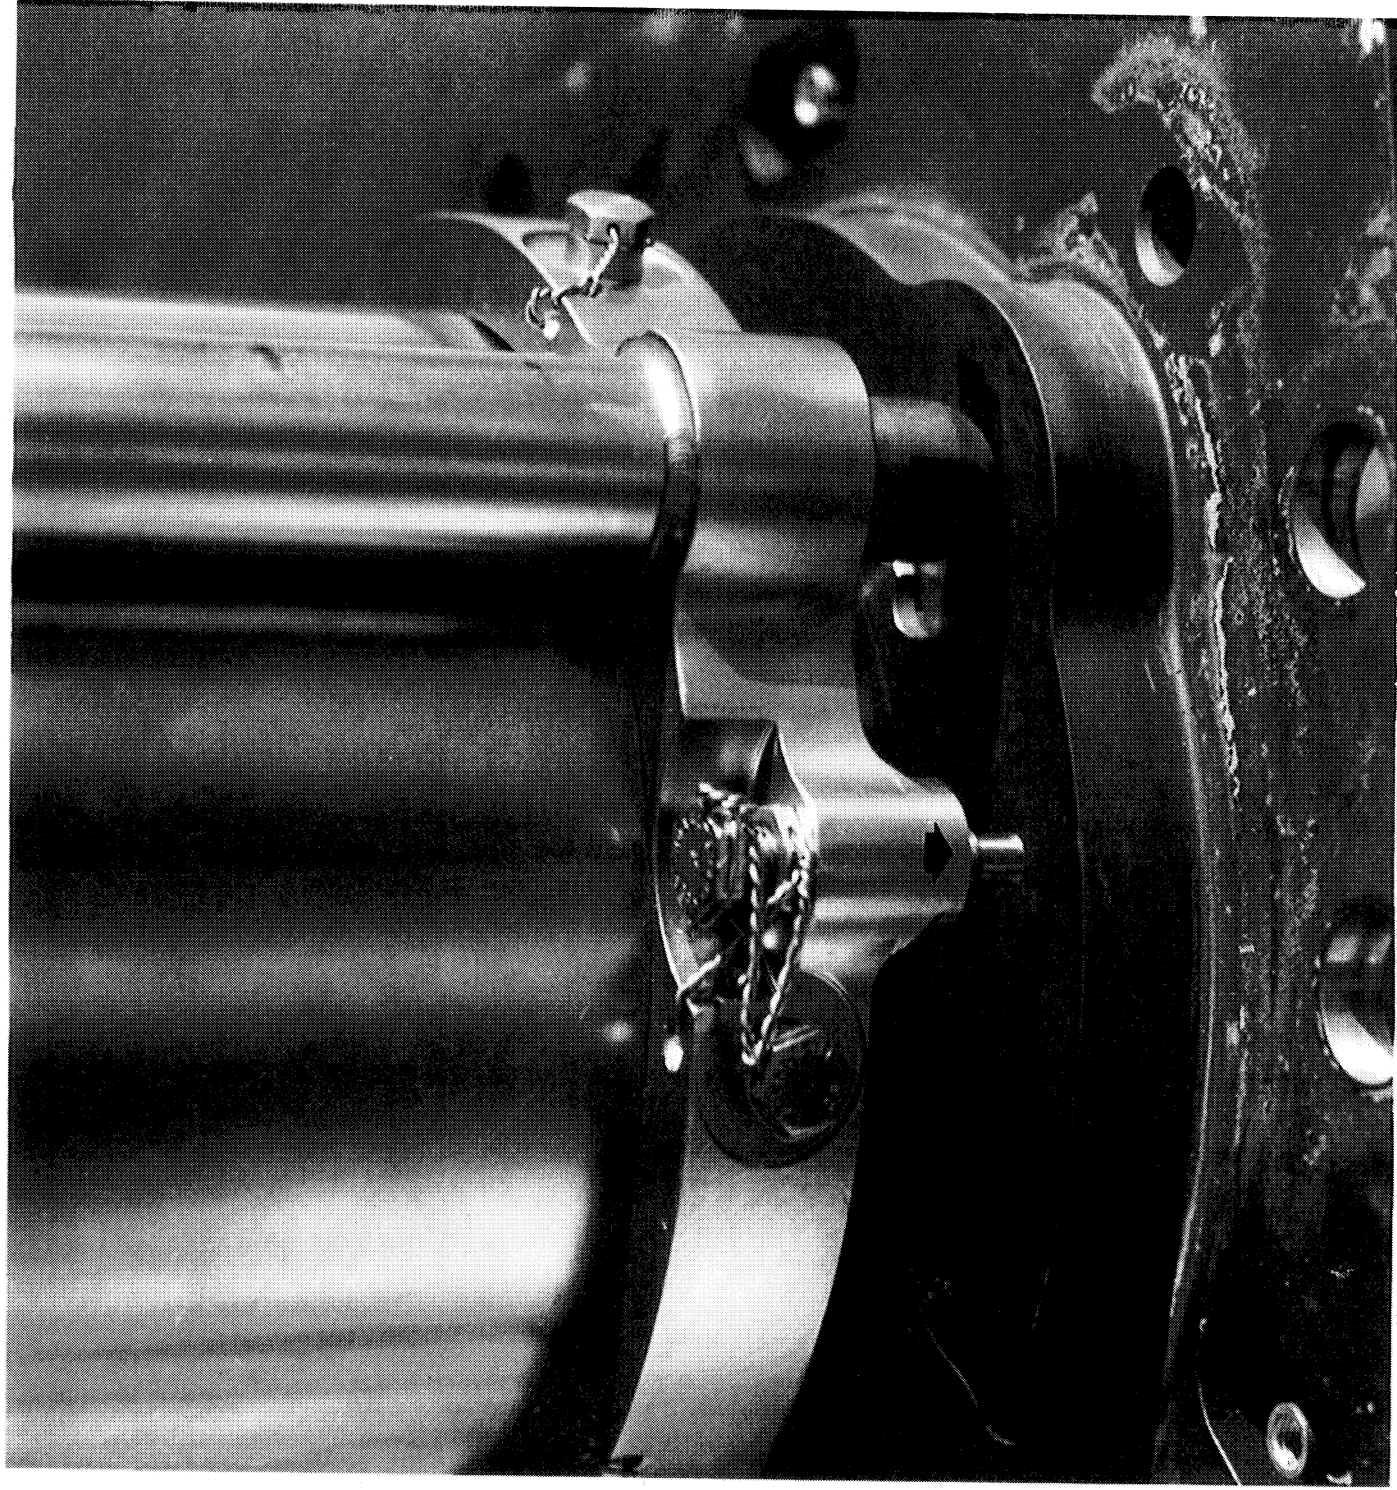
backshells, as evidenced by scratch marks on the ordnance device spring housings. The backshells were not broken as in STS-33R. The RH Y-Y centering bolt, which had bent on STS-34, showed signs of compressive loading.

Post flight examination of EO-1 attach point revealed  
compressive loading damage to RH Y-Y centering bolt
